# Inspection Report

Inspection Date February 8, 2017  
Client  
Inspector Pat Skettington

**Inspection360pros**

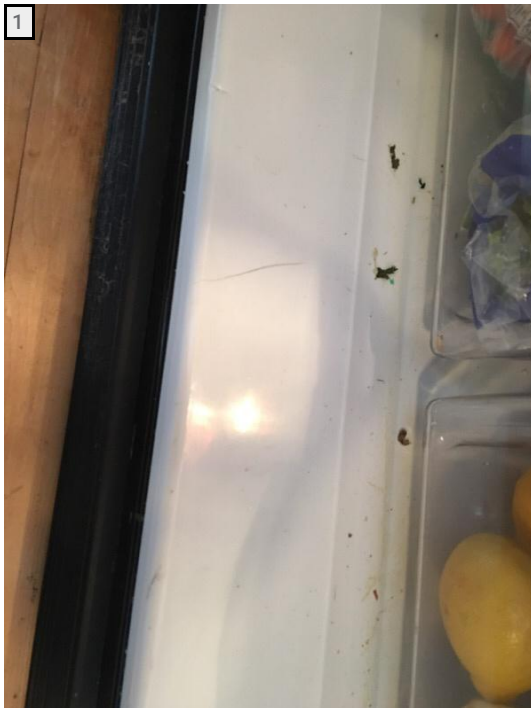
#### Minor damaged observed

Location Kitchen

Old

### Nearing the end of its useful life

Location	Kitchen
Suggested Action	Budget for a newer unit. In the interim, a higher level of maintenance can be expected

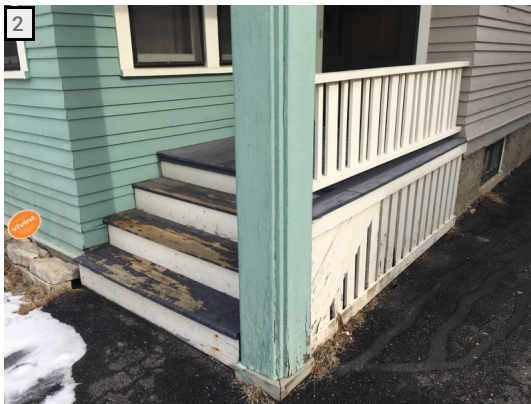
#### Guardrail is too low

Location	Exterior: Ground View
Impact	A low guardrail reduces protection from falling
Suggested Action	Repair or replace the guardrail to meet the modern code
Other Information	A guardrail is the barrier that prevents you from falling off a deck, porch, mezzanine, or the side of stairs

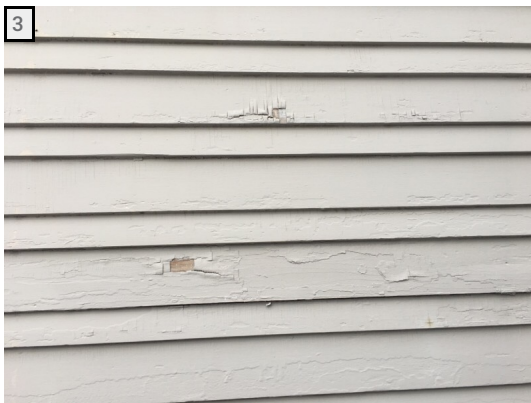
✓ **Exhaust Vent**✓ **Exterior Trim**✓ **Gutter**— **Siding****Moderate Concern****peeling paint and loose and damaged boards**

Location	Exterior: Ground View
Suggested Action	Suggest review for repair by a qualified professional.

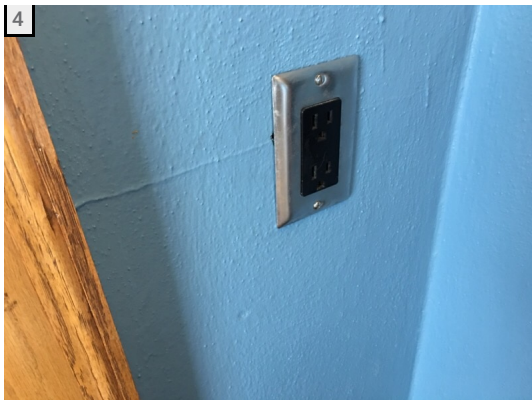
#### Missing GFCI at outlet.

Location	Partial Bathroom
Impact	GFCI's outlets are suggest near sinks.
Suggested Action	Suggest review for repair by a qualified professional.

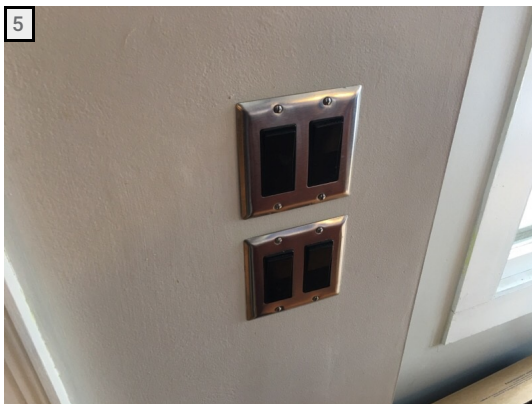
#### Not working

Location	Kitchen
Suggested Action	Replace the switch

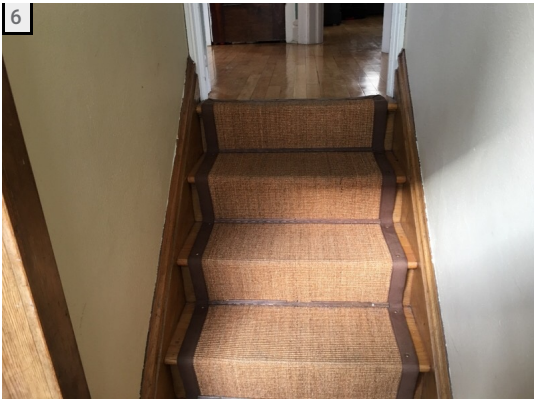
#### Handrail is missing

Location	Hallway and Stairs
Impact	A missing handrail could hinder the stair user an opportunity to stop or reduce the extent of a fall
Suggested Action	Install a handrail
